Land Characteristics, Run-Off and Potential for Rainwater Harvesting in Semi-Arid Areas of Tanzania

Abstract

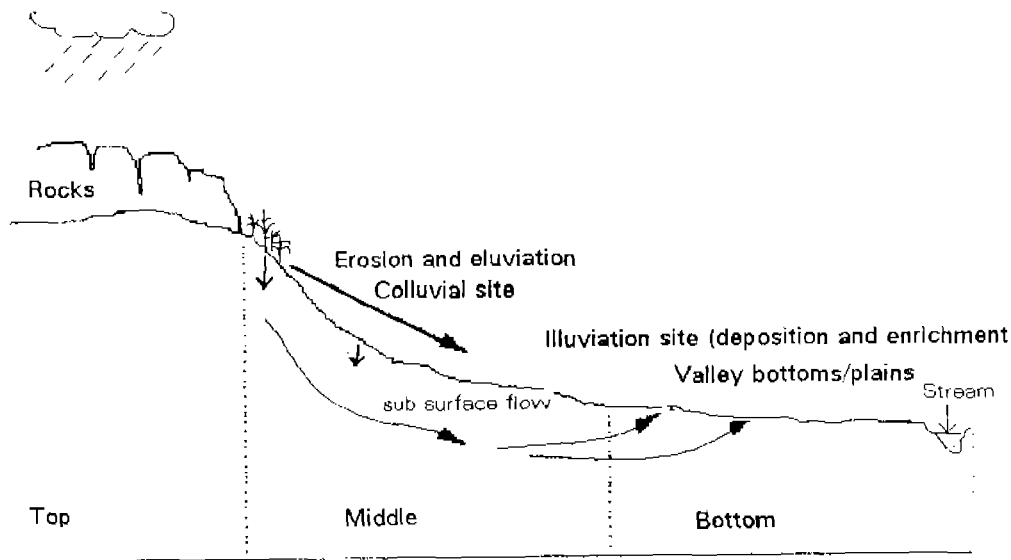
Figure 1: Water movement in a generalised catena

A catena is considered as a natural set-up for land use planning and hence for rainwater harvesting. The top section acts as a natural generator of runoff and the bottom two sections act as natural receivers (Figure 1). Important land characteristics on the catena include soil type, hydraulic properties down the profile, soil variation along the toposequence, slope and vegetation cover. The relative proportions of the three sections in a given catena, how they are used and managed, determine the amount of runoff, erosion and the potential for rainwater harvesting (RWH). The top, middle and bottom parts of the catena may vary greatly in their relative sizes.

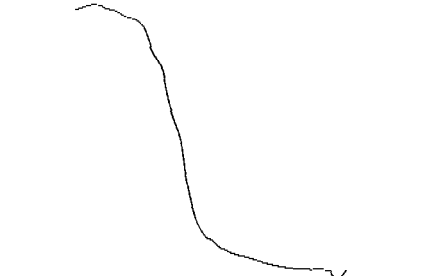
| Land Form | Attributes and RWH potential |
|--|--|
| <p>(a)</p> | <p>Very steep catchment, run-off in deep gullies moves fast. Difficult to use in the pediment spreads naturally further down in the lowland where it is opportunistically used by farmers. A example is Kifaru village in Mwanga.</p> <p>High potential for RWH.</p> |

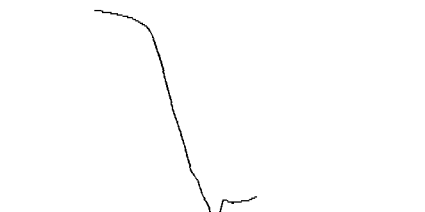
| Land Form | Attributes and RWH potential |
|--|--|
| <p>(b)</p> | <p>Very steep, a lot of run-off, no area at the bottom use it. Common in Morogoro north of the Ulu Mountains.</p> <p>Poor potential for RWH.</p> |
